Cornwall Archaeological Unit Monumental Improvement in the Cornwall AONB

Castle Dore Hillfort, Cornwall

Client	Cornwall AONB
Report Number	2021R072
Date	September 2021
Status	3 rd draft
Report author(s)	James Gossip, with contributions by Callum Booker and Ryan Gilkes
Checked by	Andy Jones
Approved by	Andy Jones
Project number	146998

As part of the Development Stage of Monumental Improvement, CAU carried out a programme of work to help assess the condition of, and develop management proposals for, Castle Dore Iron Age hillfort near Tywardreath, Cornwall.

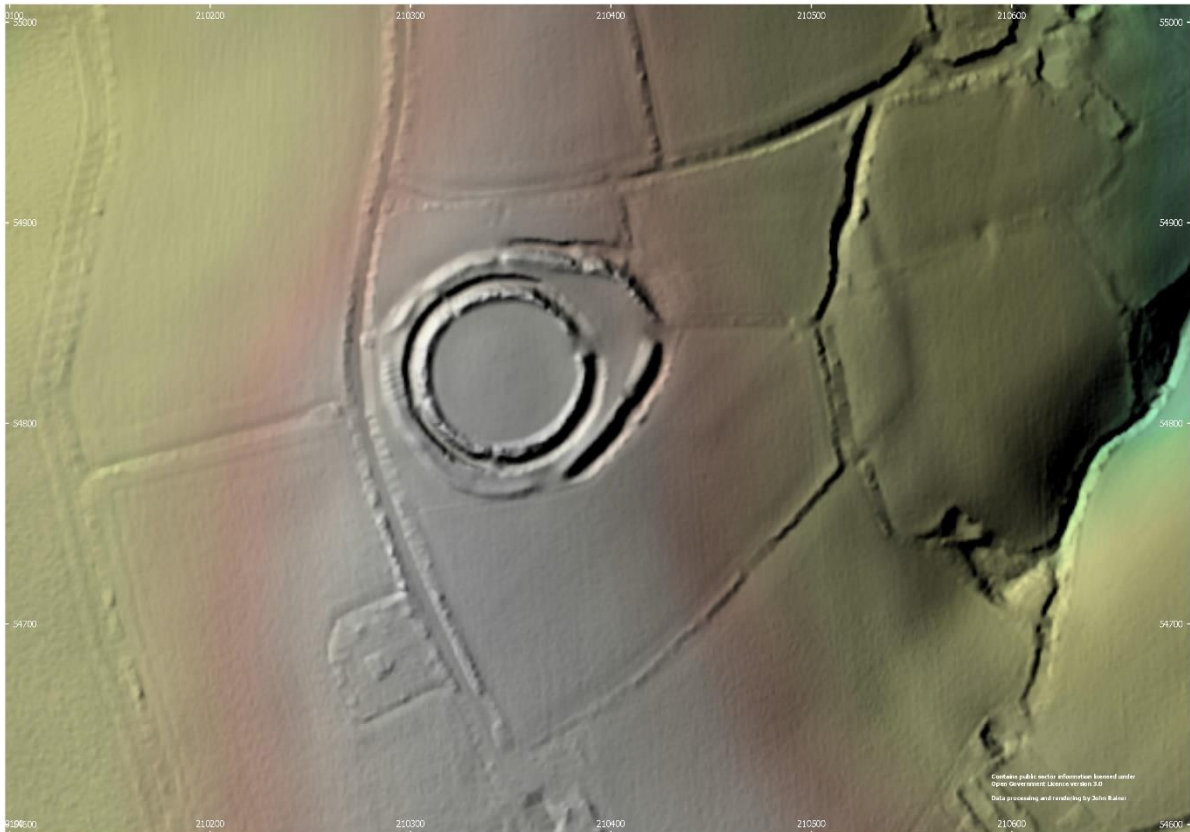
Fig 3 Lidar imagery showing continuation of the southern boundary further east into the field south of Lawhibbet.

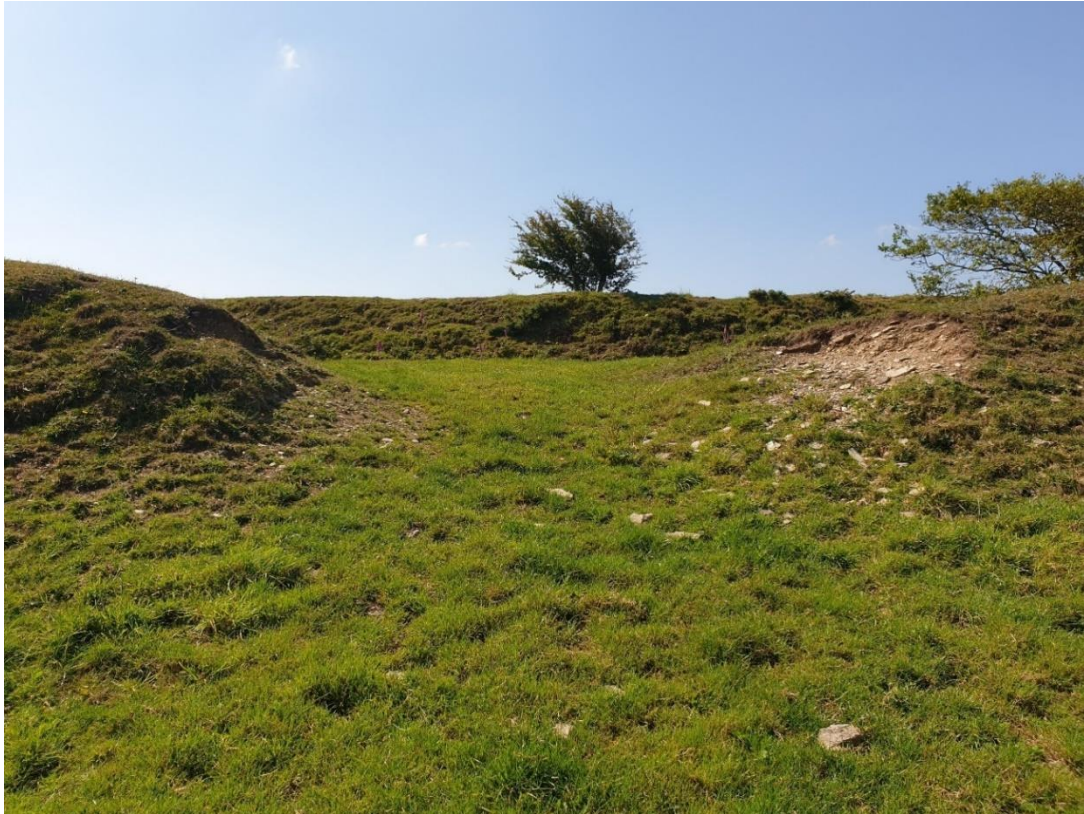
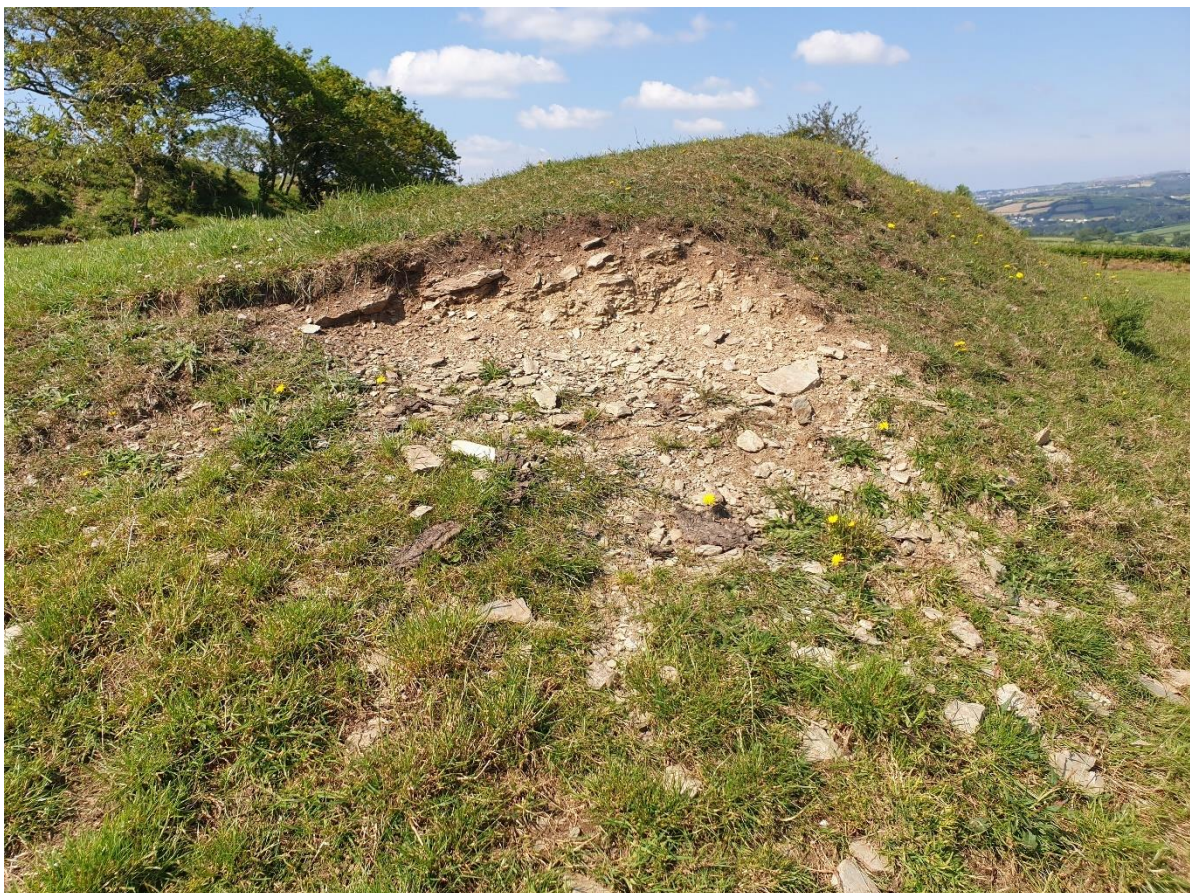
P1 erosion either side of a breach in the outer bank on the northern side.

Fig 5 Priority erosion area P1.

Fig 6 Priority erosion area P1.

- Repair erosion damage to ramparts. Initially this should be to four prioritised areas (P1 – P4, Fig 5-16). Whilst this may not necessarily provide a long-term solution, the new material would provide a 'sacrificial' layer, preserving the original rampart material. Arisings from vegetation cutting (gorse and thorn) should be pinned over the repaired sections to deter disturbance whilst material re-establish. Repairs to area P2 should be carried out pending discussions with the landowner and tenant with a view to relocating the gate and or/trough (this would require SMC).

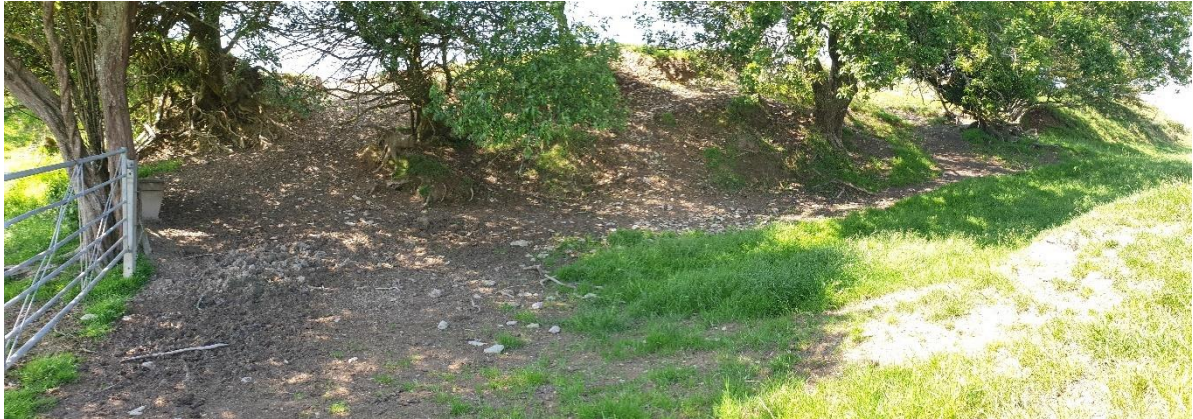
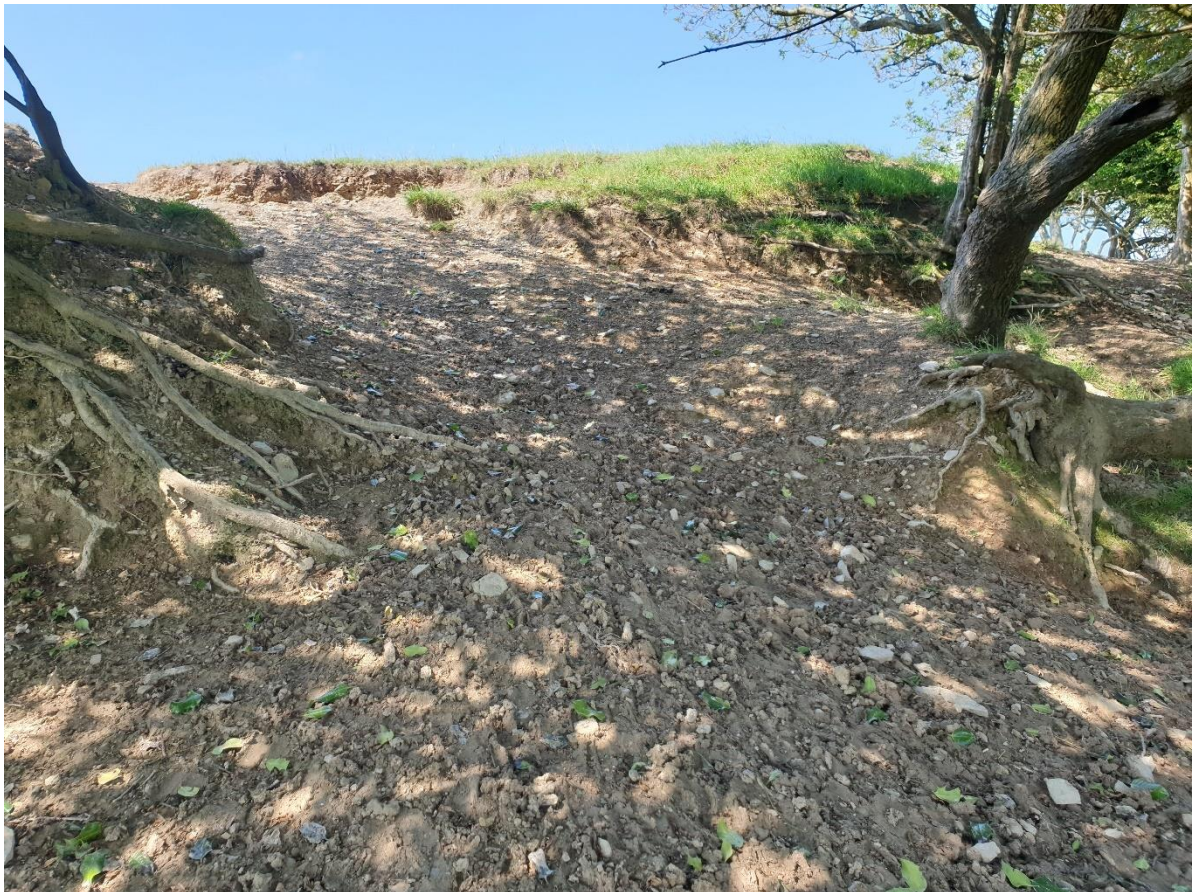
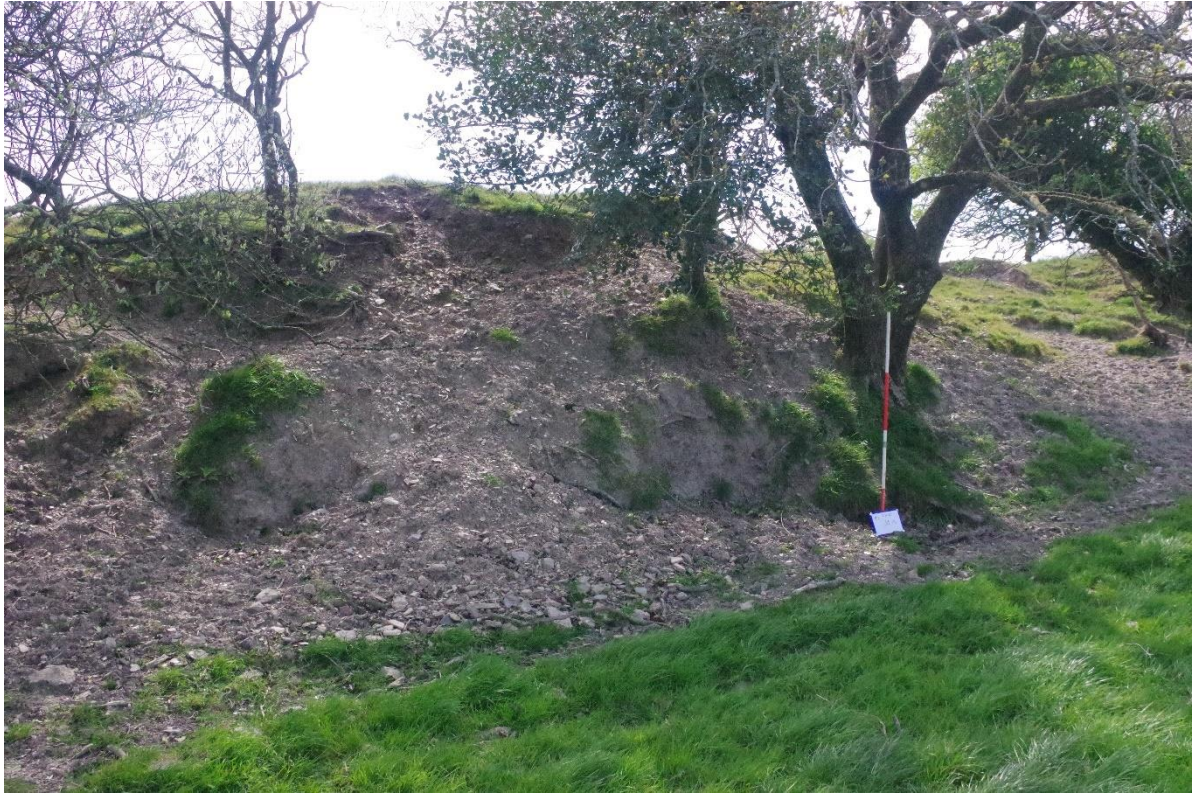
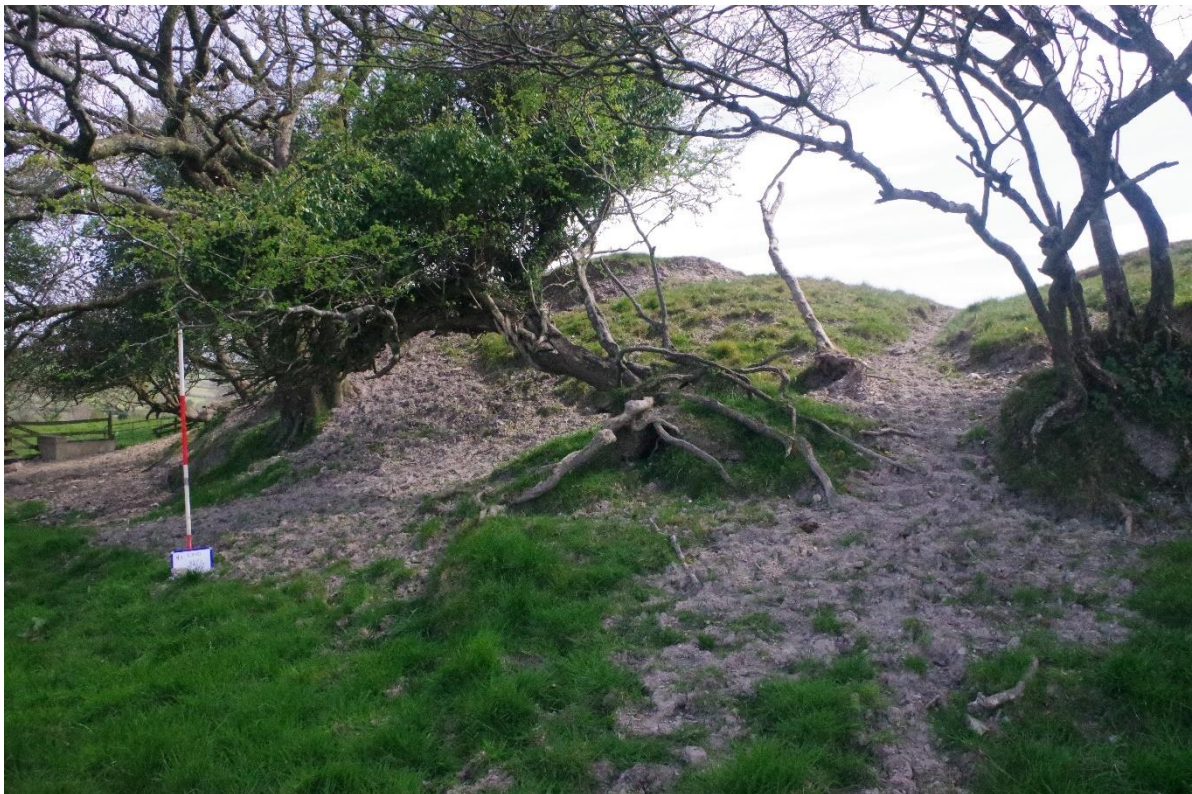
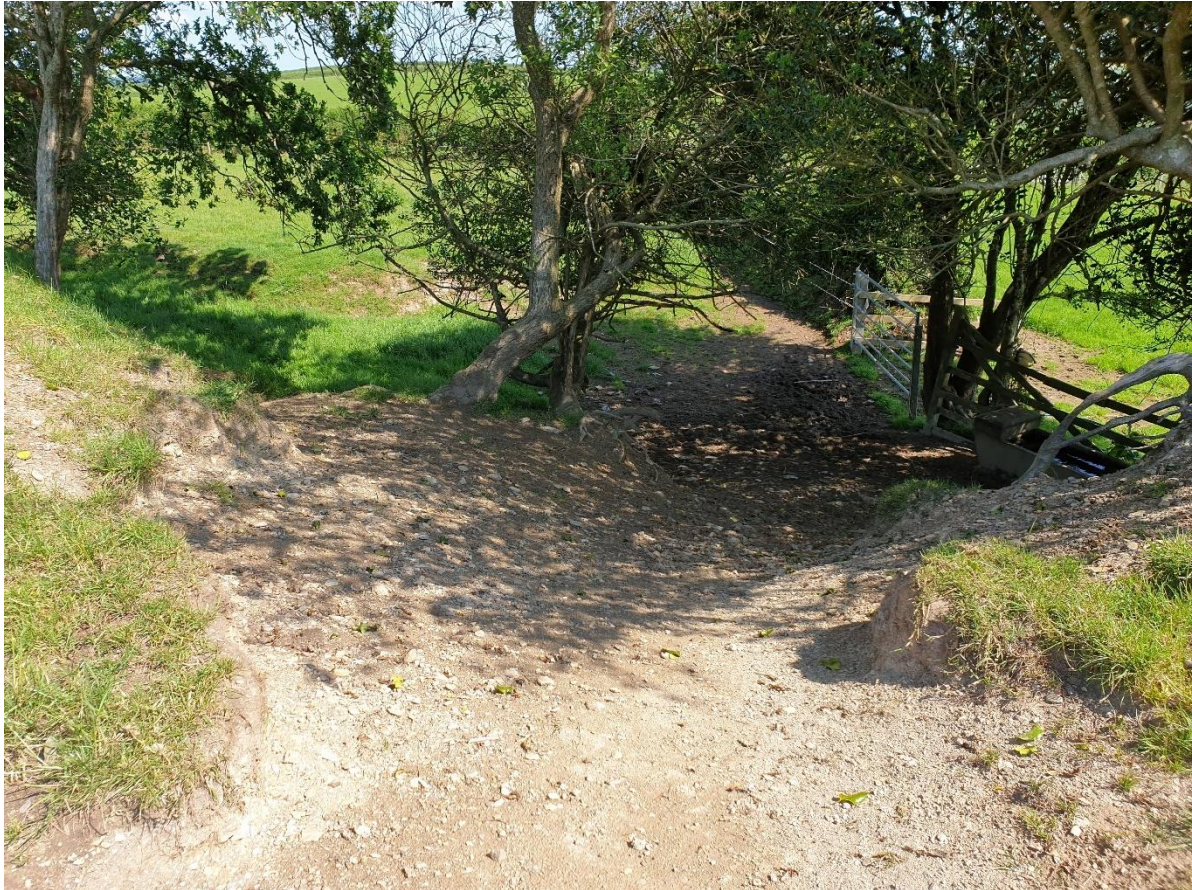
P2 a large area of erosion on the northern slopes of the outer enclosure close to a field gate and water trough, where cattle have grouped together under the shelter of trees and caused considerable damage. Discussion with the landowners and tenant should take place to discuss into relocating the gate and water trough, so restoration of this area would depend on this being an acceptable option.

Fig 7 Panorama of priority erosion area P2, with field gate and trough visible on the left.

Fig 8 Priority erosion area P2 facing upslope over the outer rampart, showing exposure of tree roots.

Fig 9 Priority erosion area P2 facing south showing the extent of damage.

Fig 10 Priority erosion area P2 facing east towards the field gate.

Fig 11 Priority erosion area P2 facing downslope over the outer rampart, field gate and trough on the right.

- Re-site the water trough and adjacent gate to encourage cattle to graze away from the monument.
- Carry out annual monitoring and scrub clearance with volunteer groups (e.g. CAS Area Reps, Truro College students).

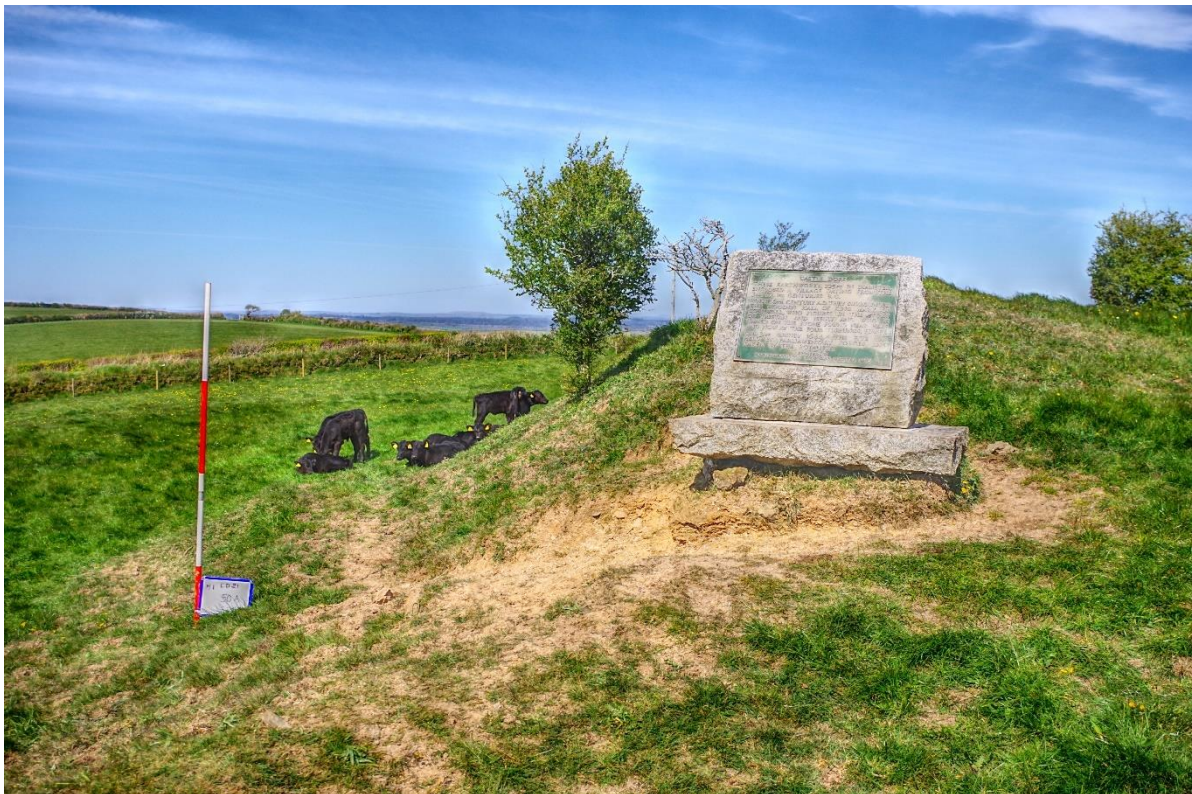
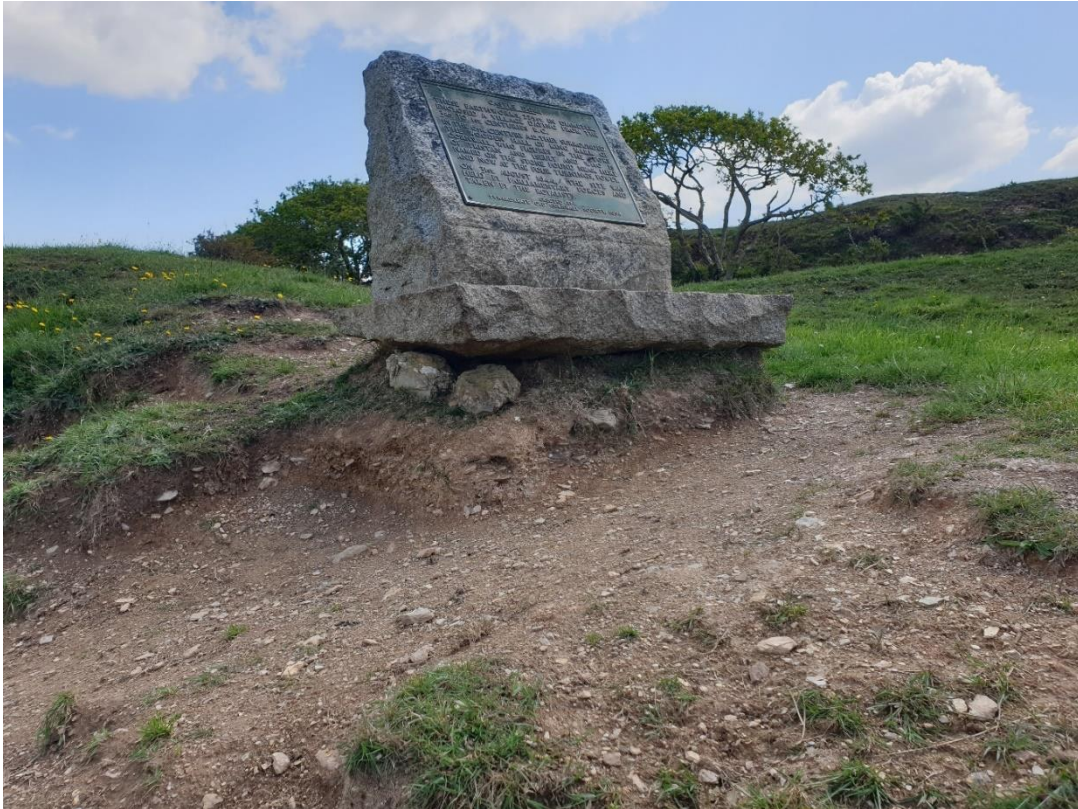
P3 erosion around the existing information panel, undermining the supporting stone plinth. The plinth should be moved outside the monument and repair should include the introduction of hardcore add to the level of protection from footfall.

Fig 12 Priority erosion area P3, showing the undermined information panel.

Fig 13 Priority erosion area P3, illustrating the precarious situation of the stone plinth and a recent attempt to support with stones.

- Retain original sign but propose that we move to a new location to the southwest, outside the area of any earthworks and rebuild/repair base to stabilise. Add QR code to access updated information.
- Geophysical survey of the interior and hinterland of the monument to help inform interpretation.
- Presentation in the form of online information (via QR codes) with the advantage in being easy to update in terms of style and content. Augmented reality content could be produced to aid interpretation of the site and could include drone flyover/walkthrough footage and 3D modelling with embedded information.
- Artists reconstructions featuring use of the site during the Iron Age and Civil War would provide attractive online and/or on-site content to help visitors understand how the site was used.

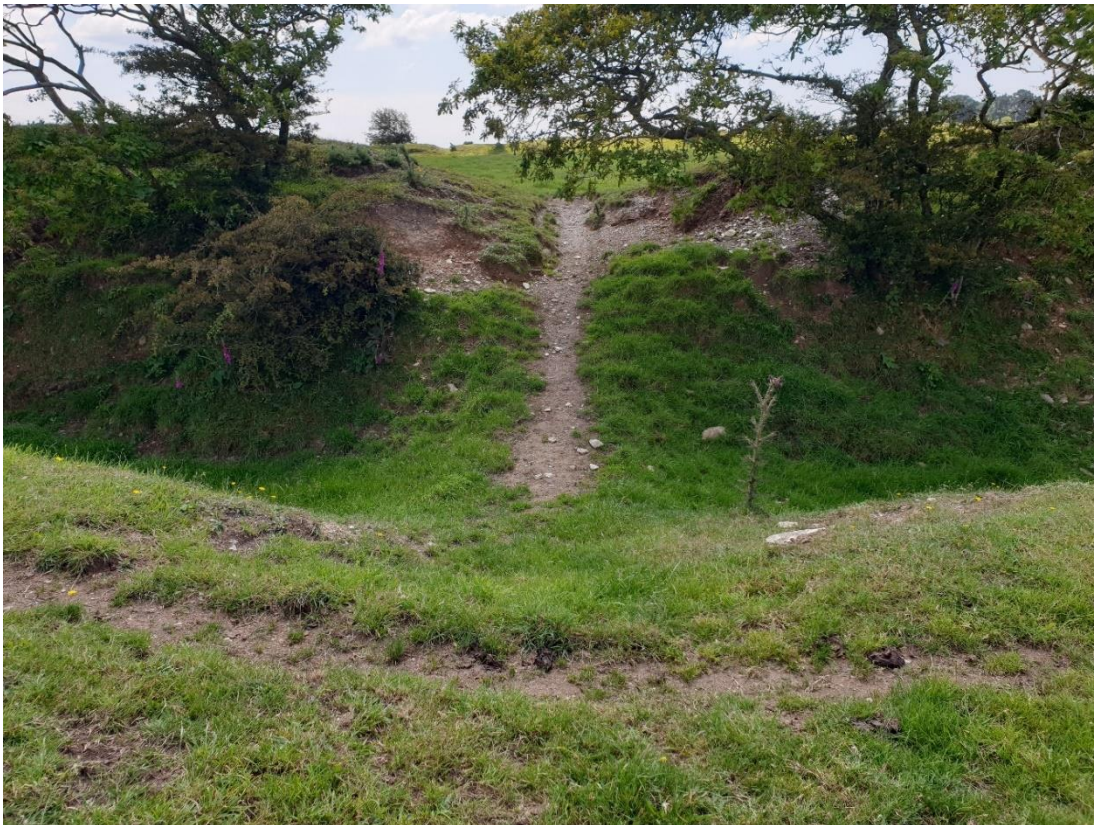
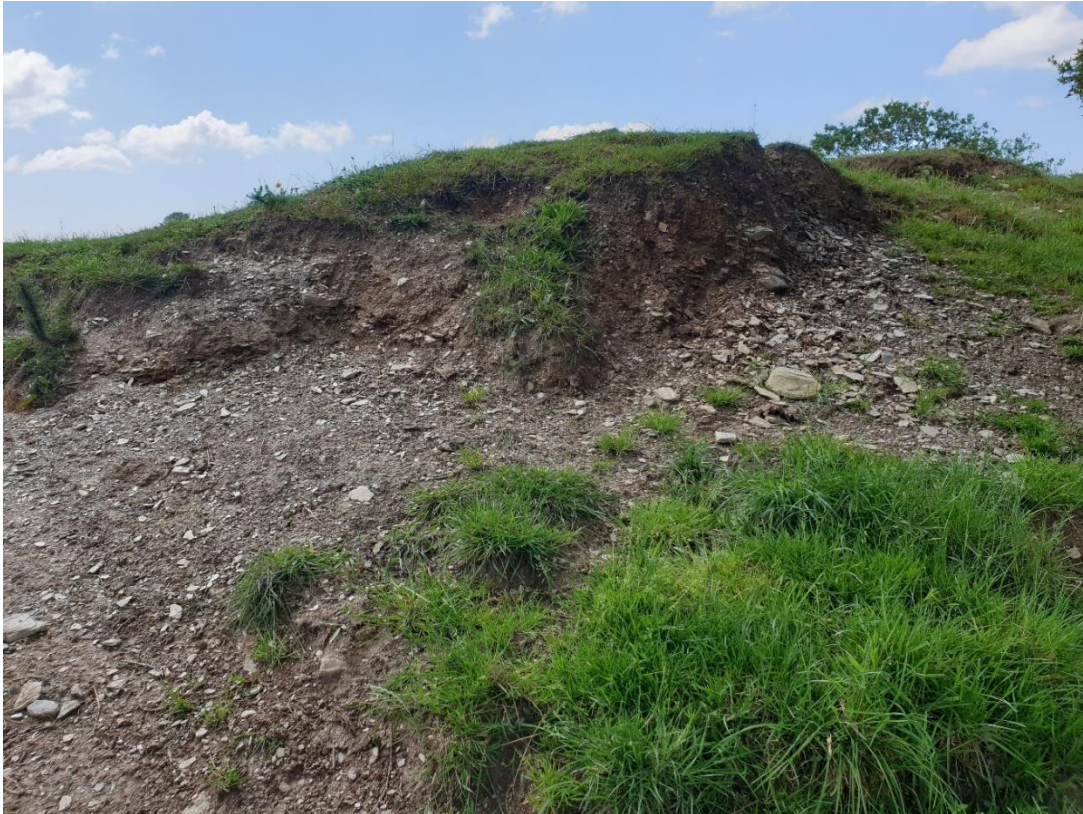
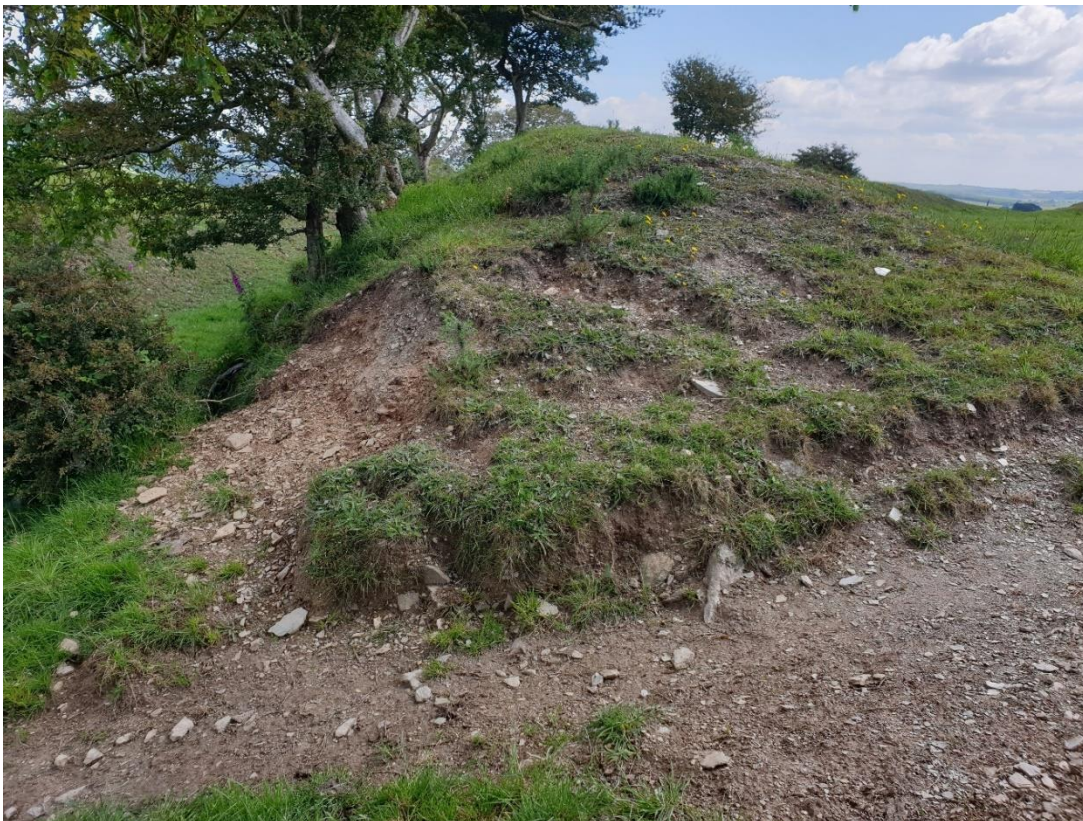
P4 erosion across the slopes of the inner rampart on the western side, used as an informal entrance into the hillfort.

Fig 14 Priority erosion area P4, facing south-east over the inner rampart, commonly used as a visitor entrance.

Fig 15 Priority erosion area P4 facing south-west, showing the exposed core of the rampart.

Fig 16 Priority erosion area P4 facing south-west, showing the exposed core of the rampart.

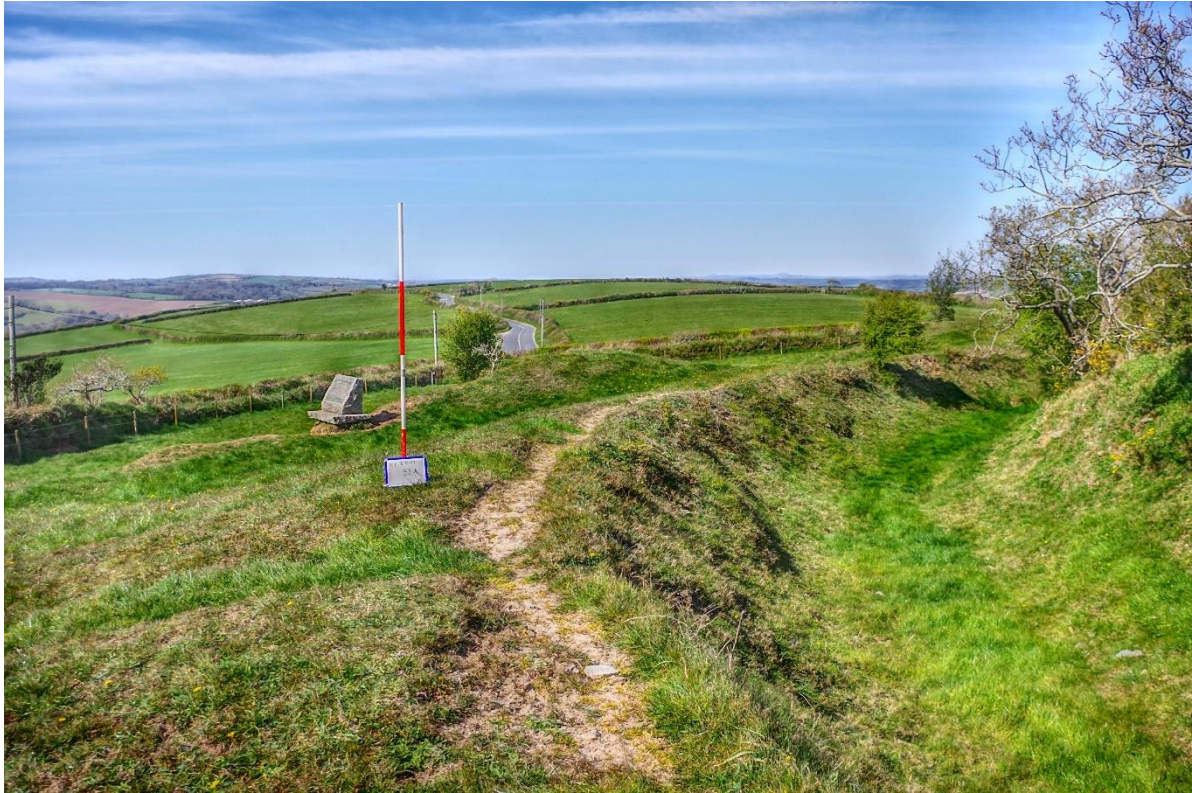
Fig 17 Erosion of a desire-line running around the west side of the monument from the informal stile in the hedge and out onto the main road.

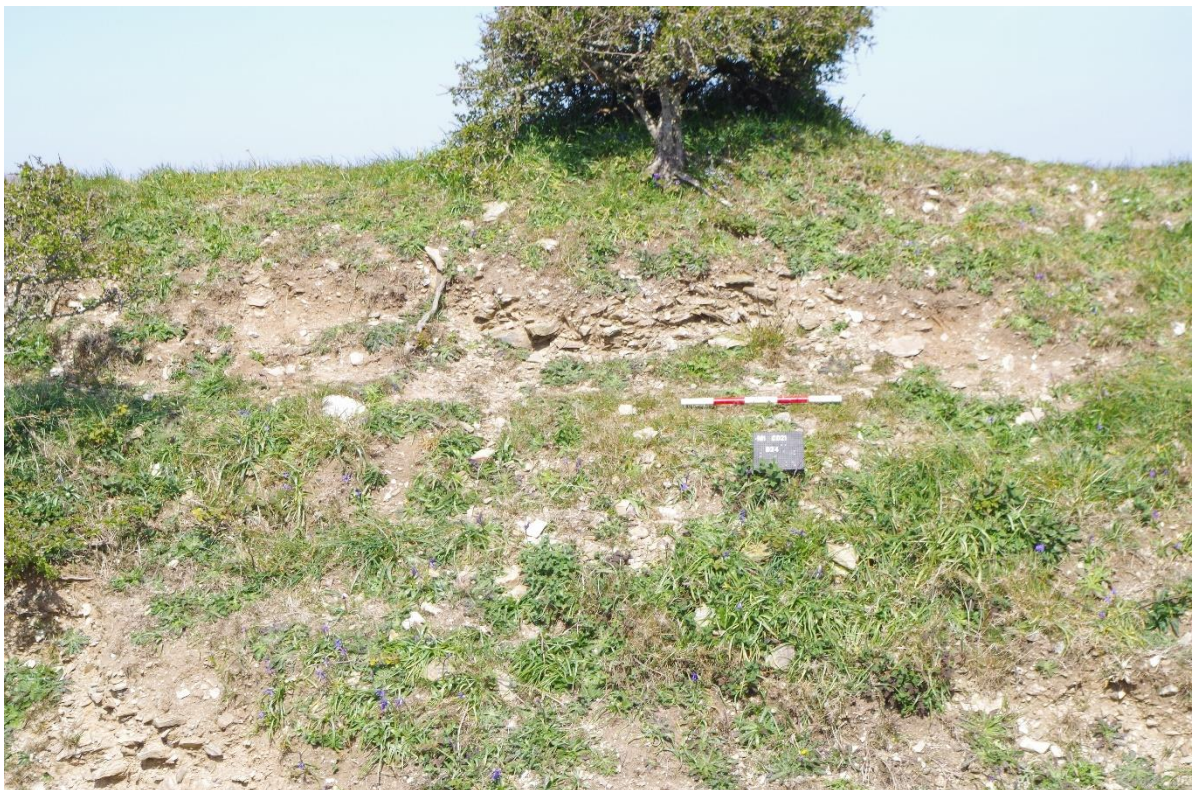
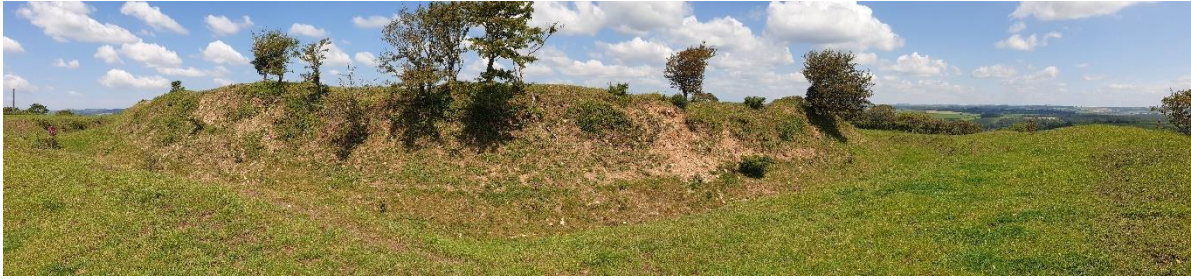
In addition, there is considerable erosion of the south and eastern slopes of the inner and outer ramparts. These should be considered for consolidation works if the priority area repairs are successful.

Fig 18 Erosion of the south side of the inner rampart, with revetment walling exposed.

Fig 19 Panoramic view of the south side of the inner rampart showing extent of erosion on the very steep slopes.

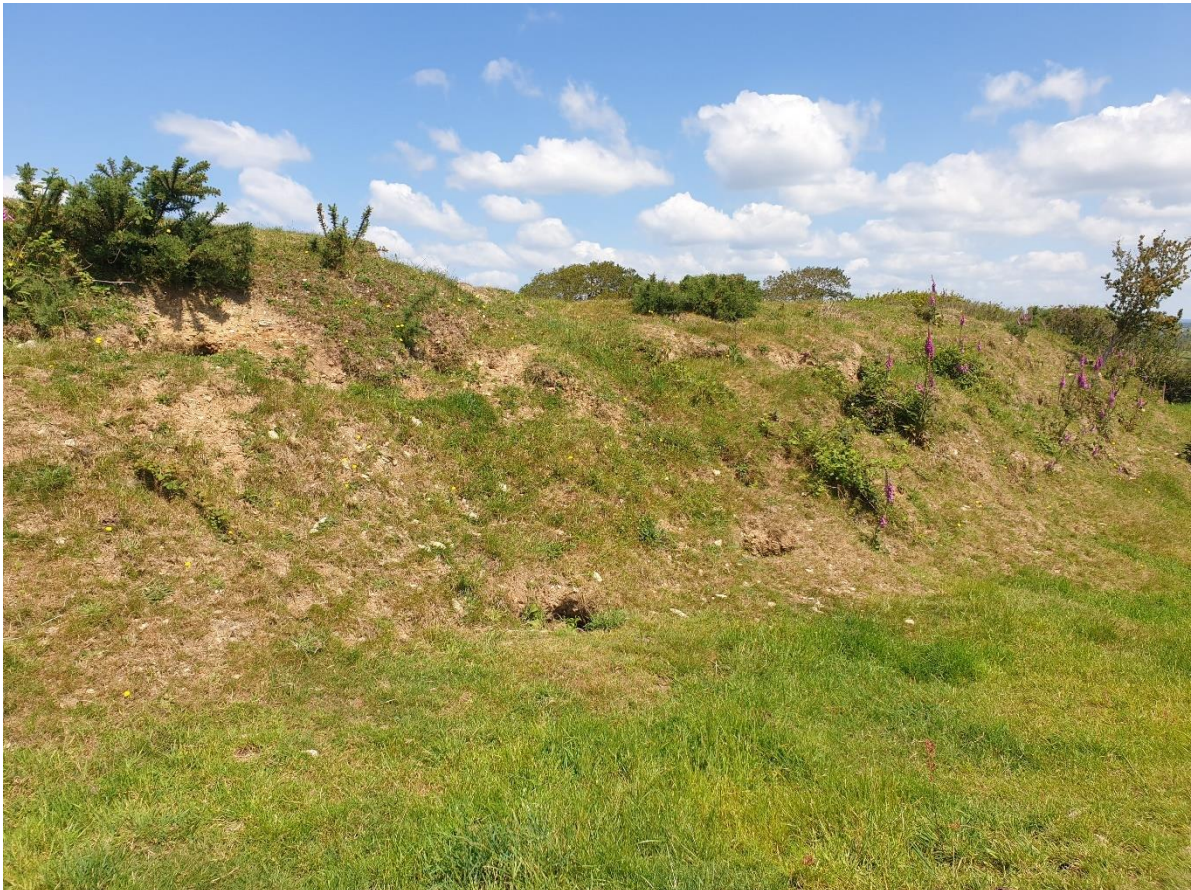
Fig 20 Erosion of the south side of the outer rampart, showing burrowing by badgers.

- Burrowing animal survey (badgers/rabbits) to establish level of damage.
